RADIO KEYLINE MODIFICATION

SCOPE: This modification applies to all Sigtronics intercom (SPA-, SDB-, SCI-, Sport-) installations that will utilize both pilot and co-pilot transmit positions. See alternate solution if using pilot only transmit position.

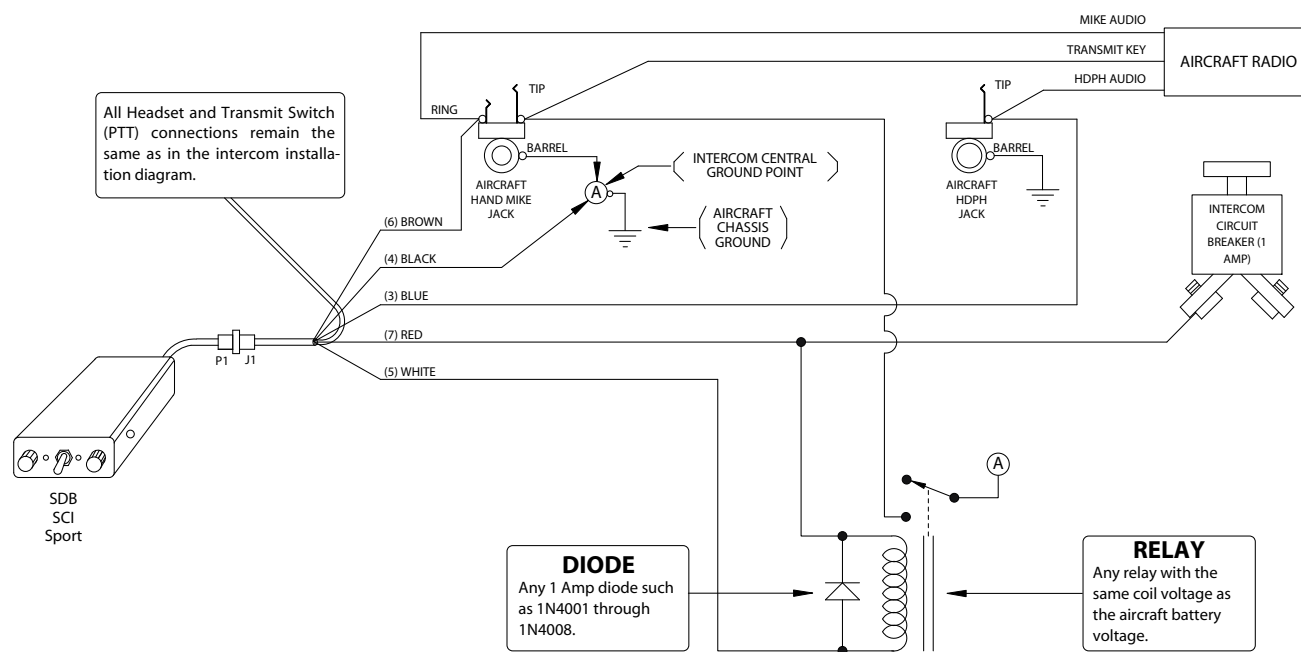
PROBLEM: The radio will not key up when either pilot or co-pilot PTT is pressed. This is due to the 0.7 volt diode drop within the intercom. Common installations affected are usually involved with the KMA-20 audio panels.

SOLUTION: A relay can be added to the installation that will eliminate the 0.7 volt diode drop. Follow the wiring diagram below.
